HVAC Field Evaluation

SDG&E Energy Innovation Center, San Diego, CA

June 2015

By: Caton Mande
Development Engineer

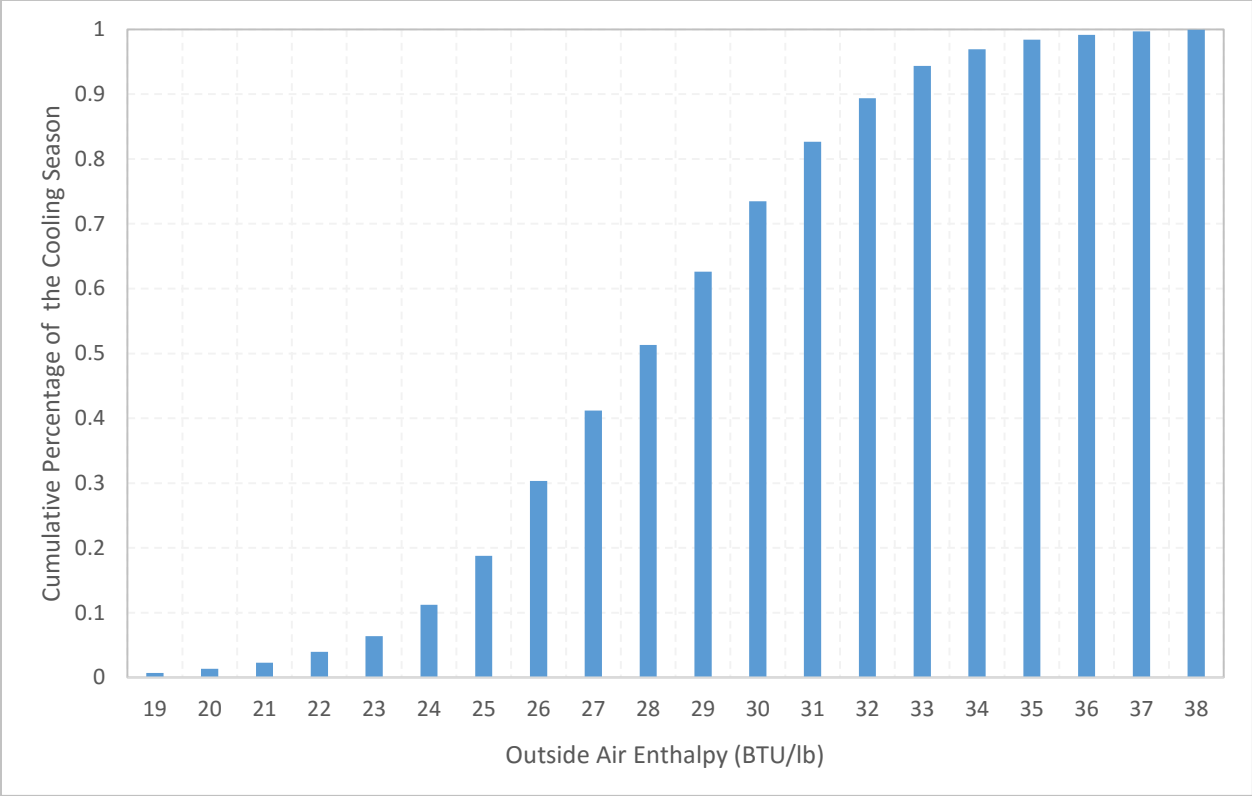
Figure 1: Cumulative percentage of outside air enthalpy (BTU/lb) measured at Montgomery Airport during the cooling season for 2013 and 2014.

1. The economizers are controlled by an outdoor air enthalpy set point of 22 BTU/lb. The EIC has an outdoor air and humidity sensor installed, however, it does not function properly (discussed further in **Long Term Monitoring**). **Figure 1**, illustrates an analysis of the local weather station (Montgomery Airport) data that shows that the set point of 22 BTU/lb was only experienced approximately 5% of the cooling season in 2013 and 2014.

Additionally, WCEC recorded an economizer change over set point of 22 BTU/lb which is low considering the conditions in California Climate Zone 7. Figure 12 illustrates the enthalpy difference between the outside and average indoor air during the cooling season at the EIC for 2013 and 2014. WCEC recommends one of two options. One option is to increase the economizer change over set point to 27 BTU/lb. This change would increase the possible economizer runtime from <5% to >40%. The second option is to use a differential enthalpy economizer which would allow the unit to use whichever airstream, return air or outside air, has less enthalpy.

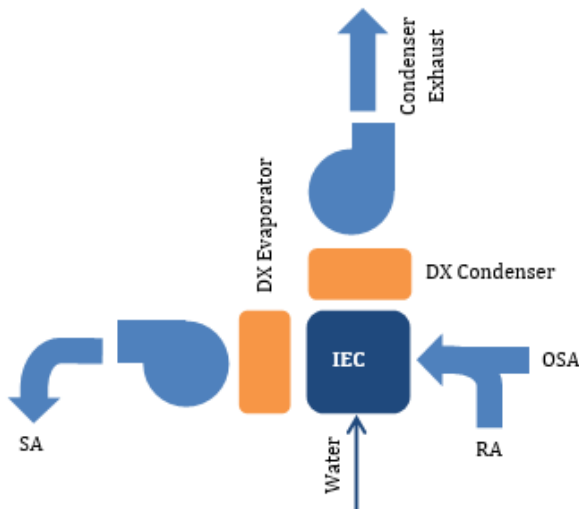
Figure 3: Airflow schematic for hybrid indirect evaporative coolers

The EIC has three packaged hybrid air conditioners that combine indirect evaporative cooling (IEC) with a small direct expansion and heating system. These three systems condition the demonstration kitchen and classroom area. **Figure 3**, illustrates the airflow for the system in cooling modes. Outside air and return air mix before entering IEC heat exchanger. The airstream is then split into a primary and secondary airstream. The primary air stream is sensibly cooled through the IEC heat exchanger then passes through the DX evaporator before becoming the supply air. The secondary airstream flows through the wet channels of the IEC, then is passes through the DX condenser before being exhausted to the ambient air.

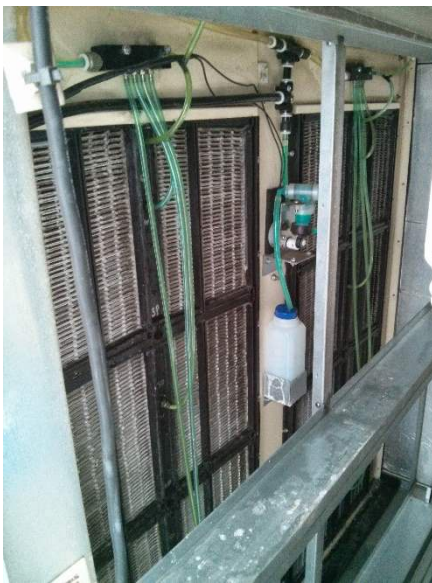
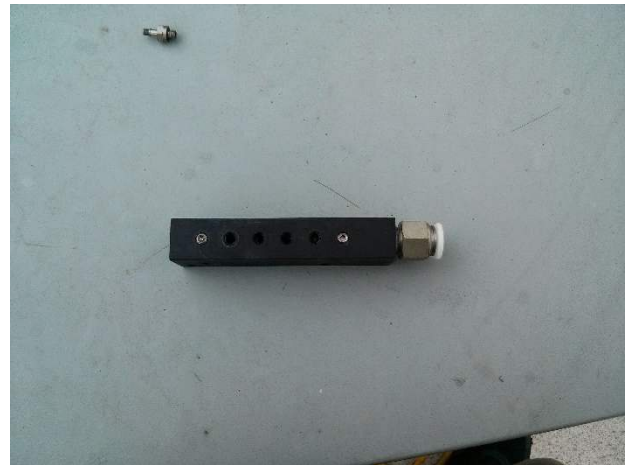
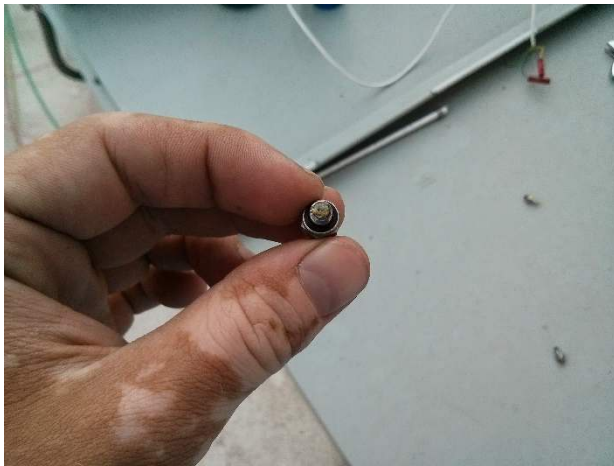
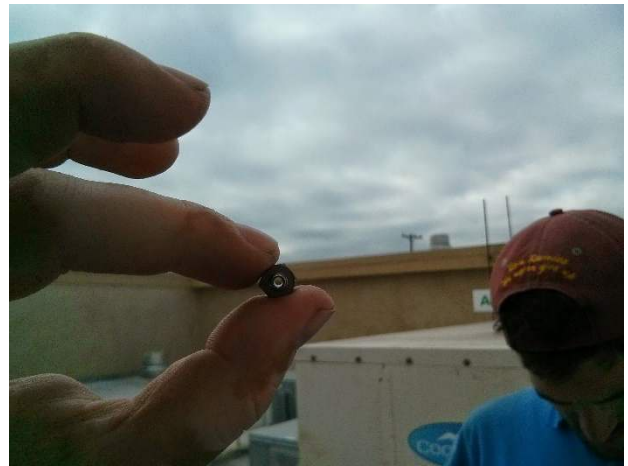
Figure 5: IEC water distribution system with clogged and cleaned adaptors

During the first visit, all three systems were observed to be functioning. However, shortly afterwards, numerous complaints were received from the occupants of demonstration kitchen for the room being too warm. After several complaints, the building manager measured a supply air temperature of 68 °F while the unit was running with the DX system. WCEC discovered that these systems had not been properly serviced since the original installation and because of that the water lines serving the IEC had been clogged (**Figure 5**).

Manifold with clogged adaptors

Clogged adaptor

Clean adaptor

WCEC had the manufacturer send a technician to service the units. During the service, the technician cleaned the water distribution system and the IEC heat exchanger for accumulated solids. Since original installation, the manufacturer had started using a different fan motor and impeller. The technician was able to upgrade both fans on all three units. The impact of this can be seen in the section *Airflow measurement* and will be further discussed in the *Discussion* section. As part of the service, WCEC had the manufacturer's technician train the EICs HVAC technician and building manager on proper maintenance for the units.
