FINAL REPORT

Automated Aerosol-Sealing of Building Envelopes

ESTCP Project EW-201511

Mark Modera
Curtis Harrington
UC Davis Western Cooling Efficiency Center

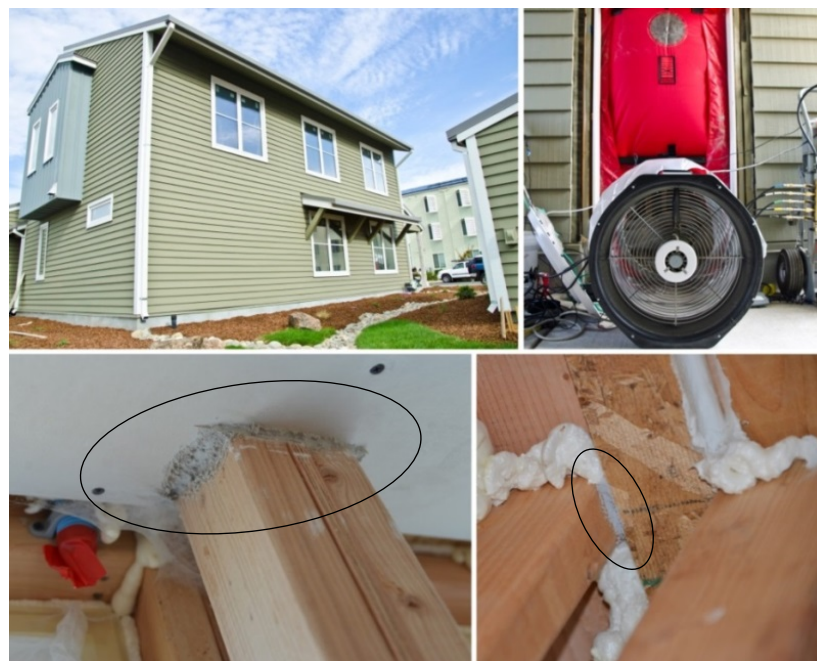
Figure 2. Photos of Aerosol Sealing Installation on Single-family Home Including Examples of Seals Formed.

One demonstration of the aerosol sealing process on the Honda Smart Home in Davis, CA, highlighted the advantage of aerosol sealing over manual methods. This demonstration achieved a reduction in building air leakage from 5.5 ACH50 to 1.0 ACH50. Photographs from this installation, including examples of seals formed, are shown below in Figure 2 and Figure 3. This building was initially sealed using standard methods and the photos show areas where the aerosol sealant found and sealed leaks that were not properly sealed with foam and caulk. The ultimate goal was to meet the very aggressive Passive House standard of 0.6 ACH50, which also requires that the air barrier be applied to the external building envelope.

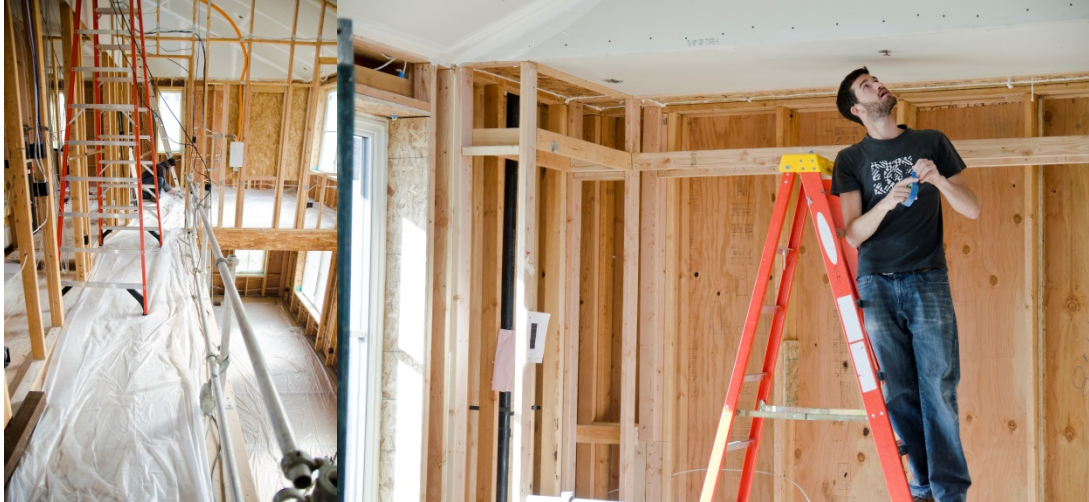
Figure 3. Photos of Honda Smart Home Before Aerosol Envelope Sealing Application.

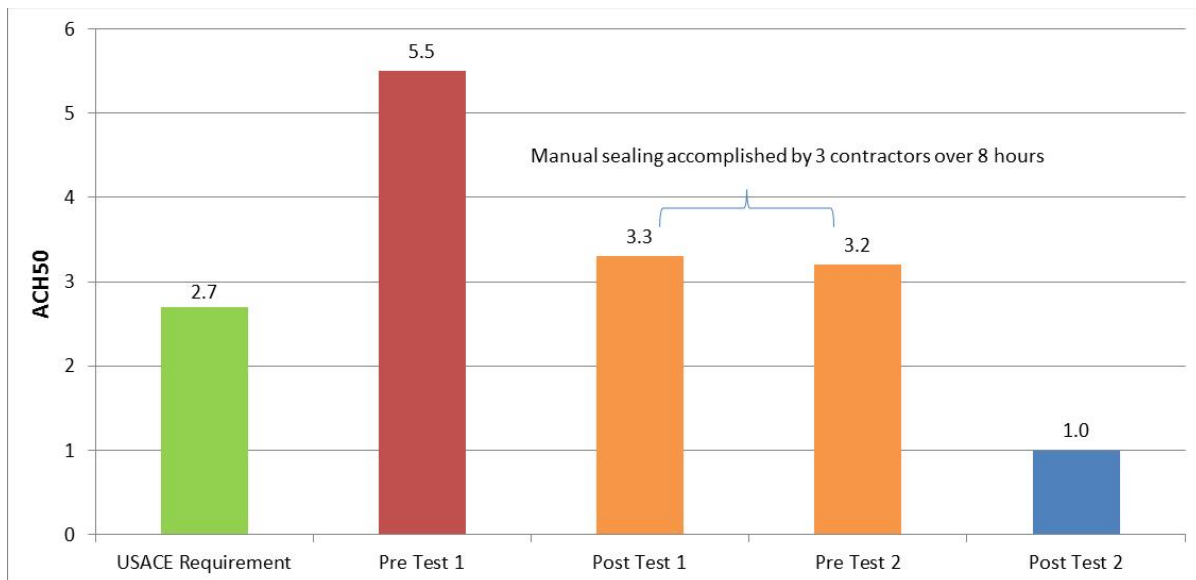
Figure 4 summarizes the results of the demonstration, highlighting the three discrete phases in the sealing process. The first aerosol sealing application used an airless nozzle injection system with five injection points and without any temperature/humidity control. This injection reduced the building leakage from 5.5 ACH50 to 3.3 ACH50. After the first application, three contractors spent 24 person-hours attempting to further seal the building manually with expanding foam and caulk, resulting in an almost negligible impact on the overall tightness of the building shell. Finally, the aerosol envelope sealing process was applied again, this time using air-atomization nozzles and temperature/humidity control. That process reduced the building leakage from 3.2 ACH50 to 1.0 ACH50 in about four hours. This is the process that is used currently including for this project.

Figure 4. Summary of Results from Aerosol Envelope Sealing Demonstration in Honda Smart Home.

This demonstration provided a superb comparison of the performance difference between airless and air-atomization nozzles, as well as the impact of temperature/humidity control. We found that while the airless atomization nozzles created a uniform particle size distribution, the air-atomization nozzles projected the aerosol with more initial momentum, allowing the aerosol to better fill the building space and promote evaporation of water from the sealant particles. However, the largest performance improvement resulted from controlling the relative humidity within the space. This was accomplished during the air-atomization application by simply heating the inlet air and controlling the liquid sealant flow rate. Evaporation of water contained in the sealant mixture is critical to allow the particles to reach the proper size and to adhere to leak sites.

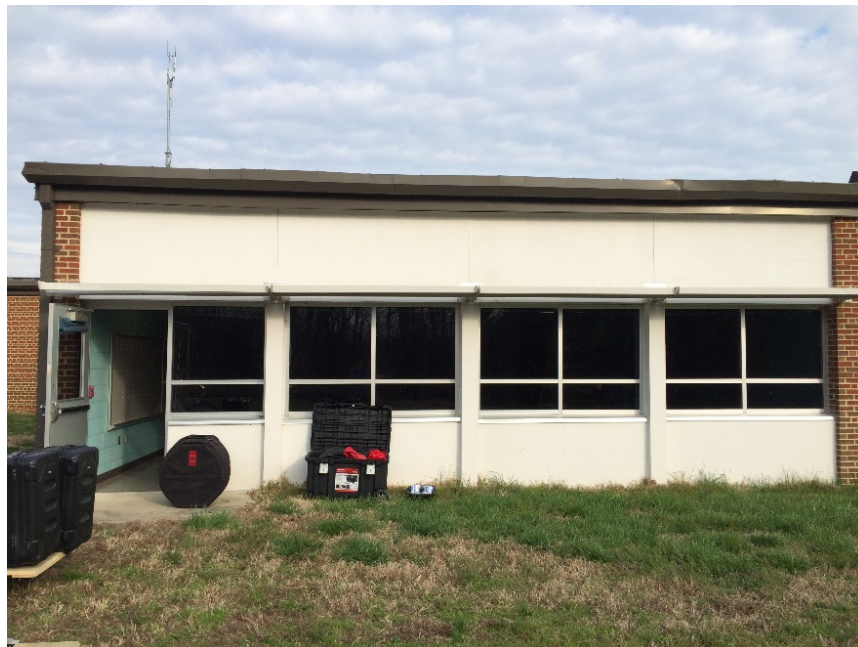
The demonstrations at Quantico included a wing of the Ashurst Elementary school and an office building (Figure 5). The 5,000 ft² elementary school wing included four classrooms and an adjoining hallway that were sealed over three different demonstrations. The school was closed in 2015 and is being repurposed as a training ground and eventually additional office space. This building was also used for the initial training of TMI staff who was involved in each of the demonstrations for the project.

Figure 5. South Classroom at Ashurst Elementary School Sealed at Quantico MCB

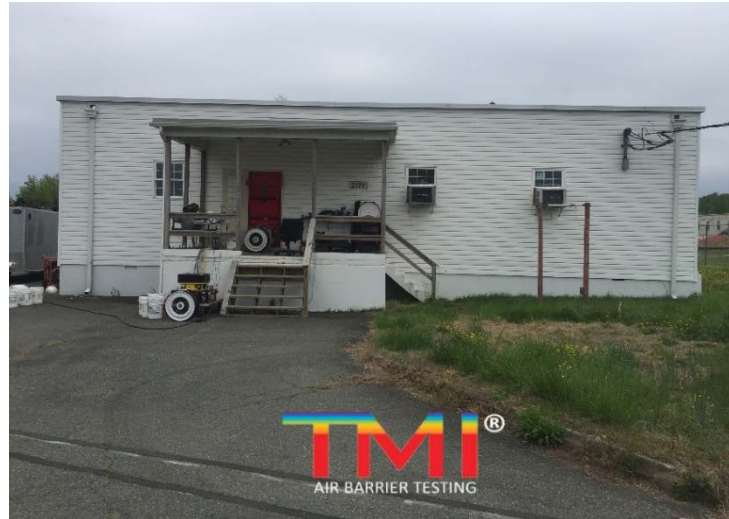
The office building at Quantico was the final demonstration completed for this project. This building was unoccupied at the time of the demonstration but was expecting to be used in the near future as office space (Figure 6). Given the status of this building, it was the only demonstration that required detailed preparation to protect surfaces from sealant deposition.

Figure 6. Office Building Sealed at Quantico MCB

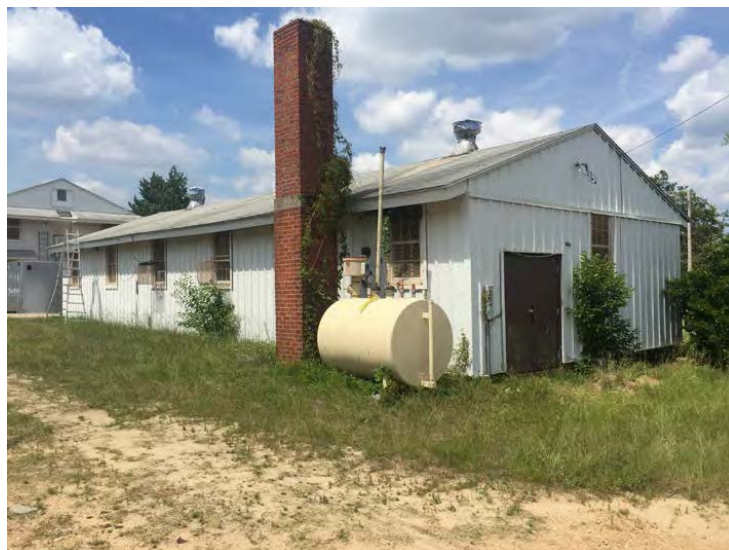
Building A5436 is a one story WWII era frame structure on a crawl space open to the outdoors, and in poor condition (Figure 7). Bathroom ceilings were collapsed and required temporary blocking during the sealing process due to the size of the hole.

Figure 7. Building A5436 at Fort Bragg Army Base

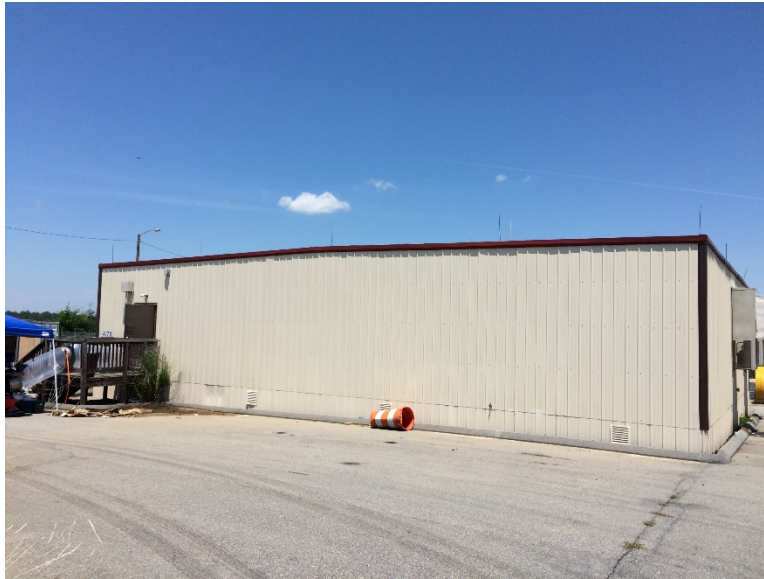
Building A6372 is a one story relocate-able metal structure on a crawl space vented to the outdoors. The building was in fair to pool condition and part of the floor was partially collapsed.

Figure 8. Building A6372 at Fort Bragg Army Base

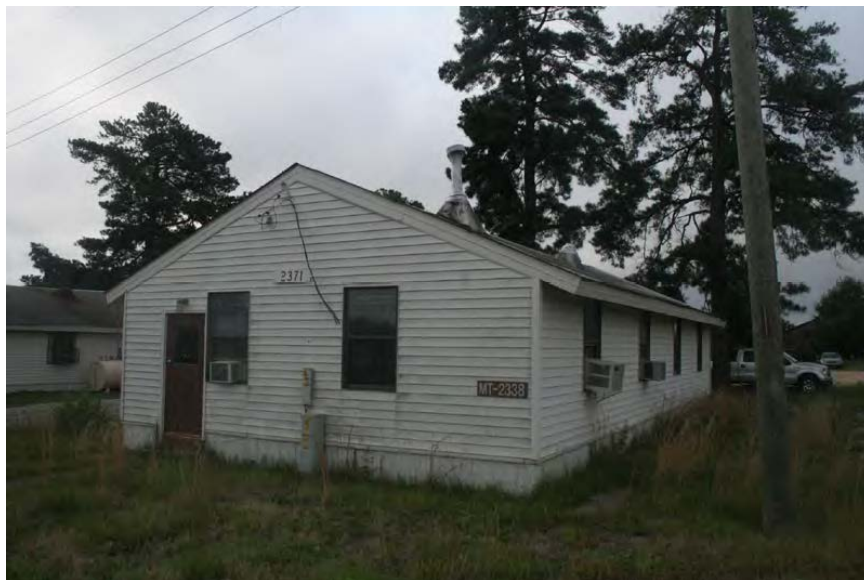
Building M2338 is a one-story wood frame slab-on-grade structure with sloped gable roof and ridge vent (Figure 9). No soffit venting was observed at the building. The buildings were in poor condition and about 2/3 of the ceilings were collapsed and open to the attic.

Figure 9. Building M2338 at Fort Bragg Army Base

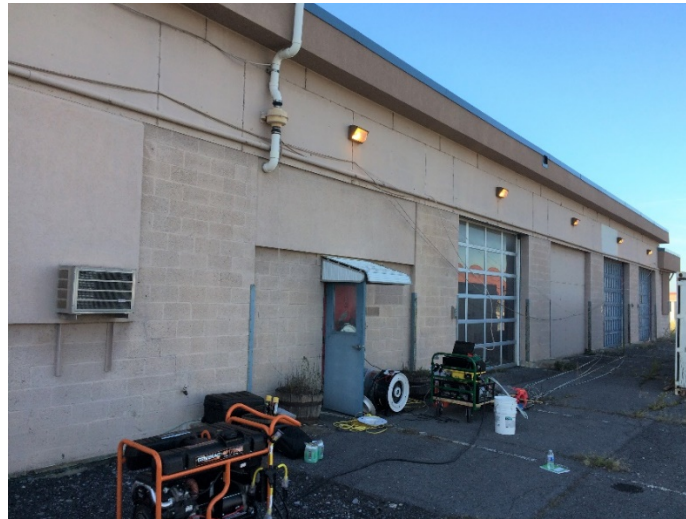
Building M-608A is an industrial facility used for training electricians. The building was about 8,400 ft² and was a conventional concrete-masonry-unit (CMU) commercial frame structure on a concrete slab. The garage doors were deteriorating and the building was scheduled for demolition.

Figure 10. Building M-608A at Mechanicsburg Navy Base

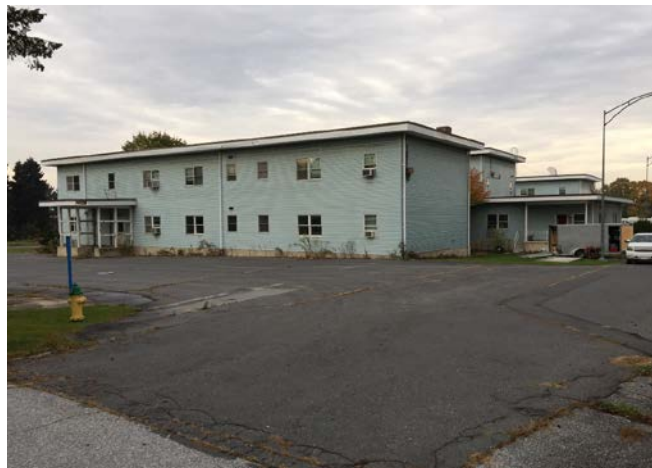
The apartments sealed at Mechanicsburg Navy Base were located at 5450 Carlisle Pike, Mechanicsburg, PA (Figure 11). The building is a conventional wood-frame structure on a poured concrete basement. The building was in poor condition and scheduled for demolition. Five apartments were sealed each measuring about 2,000 ft².

Figure 11. Apartment Complex Where Several Apartments Were Sealed at Mechanicsburg Navy Base

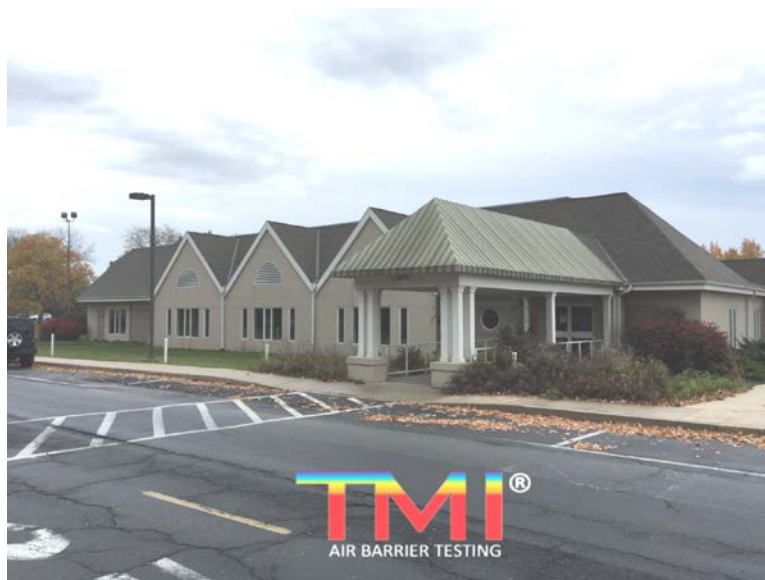
Building 15 Officer's Club at Mechanicsburg Navy Base was the largest facility sealed with the aerosol envelope sealing process. The building is about 22,000 ft² and includes a large ballroom, commercial kitchen facility, and several other gathering rooms (Figure 12). The OC is a one-story building on a crawl space foundation, in poor condition and slated for demolition. The original building is circa 1940/1950, with two later building additions. The original section is CMU wall with low slope roof over wood rafters. The first addition is frame with steep slope roof over wood trusses enclosing a non-vented attic. The newest addition is conventional steel frame with steel stud walls, low slope roof over metal bar-joist type trusses, and steep slope roof over light weight metal trusses on the 3 elevations visible from the streets.

The steep slope roof portion of the newest addition has a "ventilated conditioned attic". The insulation is on top of the steep slope roof panels. A suspended ceiling separates the underside of the roof from the conditioned finished floor space below (therefore the space above the suspended ceiling forms an attic within the thermal envelope). The soffits were ventilated to the outdoors and open the space above the suspended ceiling. The OC building was substantially larger than any others planed or sealed in the ESTCP demonstrations, and more equipment was required than available. For this reason, TMI™ attempted to seal the building in sections, starting with the steep-slope roof sections.

Figure 12. Building 15 Officer's Club at Mechanicsburg Navy Base

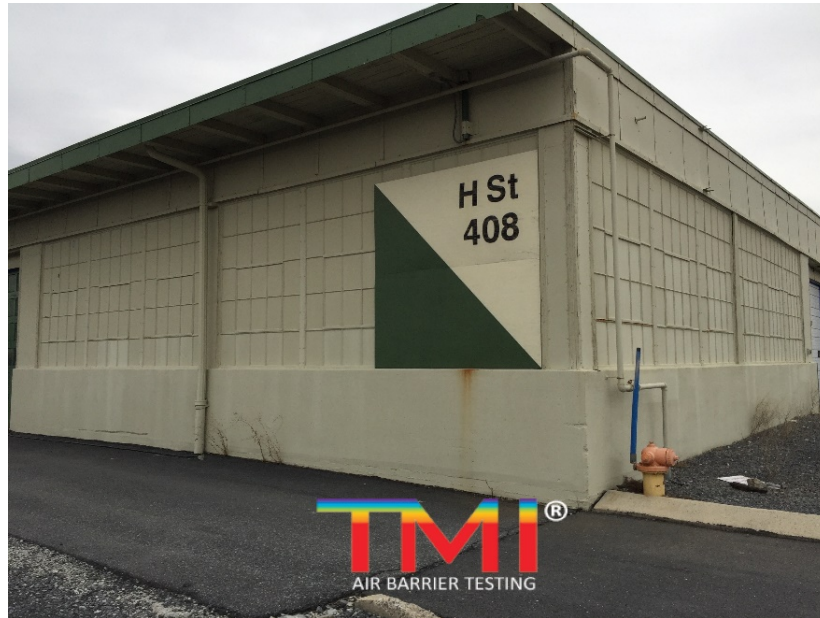
Building 408 is a 128,000 square foot single story wood frame warehouse structure (Figure 13). Construction is heavy wood timber frame with low slope wood frame roof deck and slab on grade floors. Raised clearstory lighting wells constructed of wood framing with painted transite asbestos cladding and painted steel tilting windows extend above the main roof line. Curtain walls are a combination of CMU, tilting steel windows with painted glazing, and wood stud framing with painted transite asbestos panel exterior cladding. The overall structure is divided into four sections by masonry firewalls. The three sections toward the North are occupied by offices and warehouse space and appear to be in good condition.

The southernmost section of Building 408 is designated 408S and is approximately 32,000 square feet. 408S was vacant at the time of the aerosol sealing demonstration. The curtain walls and cladding and most of the heavy timber framing appear to be in good condition, but the roof and clearstory are in poor condition. Roof leaks were apparent in numerous locations. Repairs had been made to a few of the heavy timber columns that were compromised by roof leaks. Bays 28, 29, & 30 of had been partitioned off from slab to roof deck, resulting in a 3,600 square foot section of warehouse space suitable for the demonstration.

Figure 13. Building 408 at Mechanicsburg Navy Base

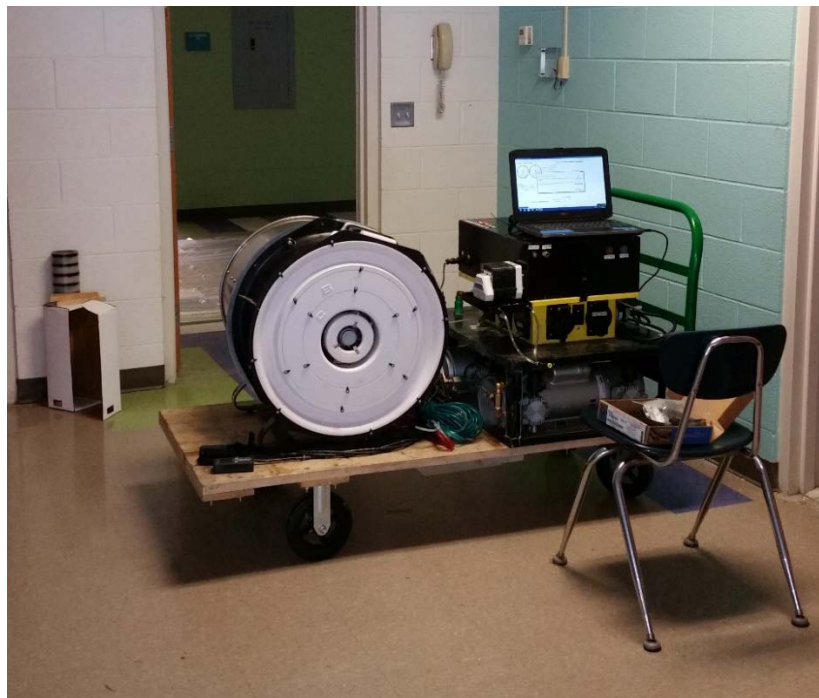
The injection system consists of an air compressor, sealant injection pump, and nozzles. The injection system is controlled to maintain the humidity target during the process in order to promote seal durability while also limiting sealant deposition on the floor. Each injector nozzle is placed strategically around the building to allow for adequate aerosol distribution. Depending on the building geometry, a single nozzle can seal up to 400 square feet of floor area.

Figure 14: Photo of aerosol sealing equipment setup

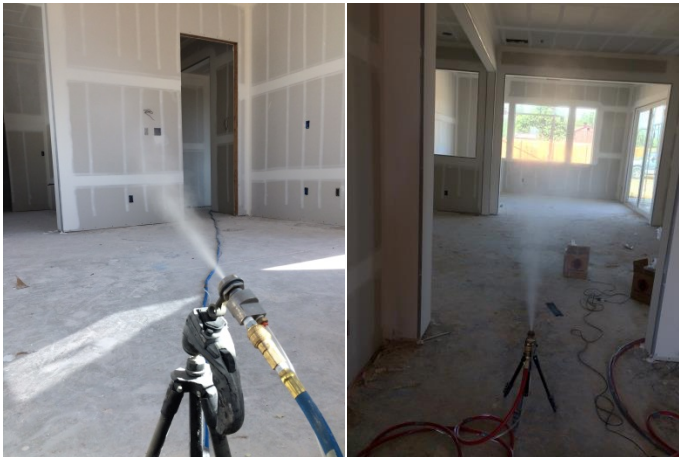
1. Setup the blower door and run combo-cords through the doorway
2. Run a multipoint leakage test or single point test at 50 Pa or 75 Pa
3. Identify and block any leaks that are larger than the sealing capabilities of the aerosol process (leaks > 3/8")
4. Temporarily seal any known intentional leaks with duct mask, tape, or other means
5. Cover anything that should not have sealant deposition on it with plastic or tape
6. Place the aerosol injection nozzles in the unit using these guidelines:
 - a. Nozzles should be distributed throughout the building
 - b. Nozzles should be oriented such that the spray is
 - i. NOT directed into the pressurization air flow stream
 - ii. NOT directed onto walls or other vertical surfaces.
 - c. Aerosol fog is distributed throughout the building
7. Spray water from the nozzles to determine final orientation

8. Measure the temperature and relative humidity of the air source
9. Control the blower door to maintain 100 Pa inside the unit
10. Set the injection rate to achieve a calculated 90% relative humidity
11. Start sealing

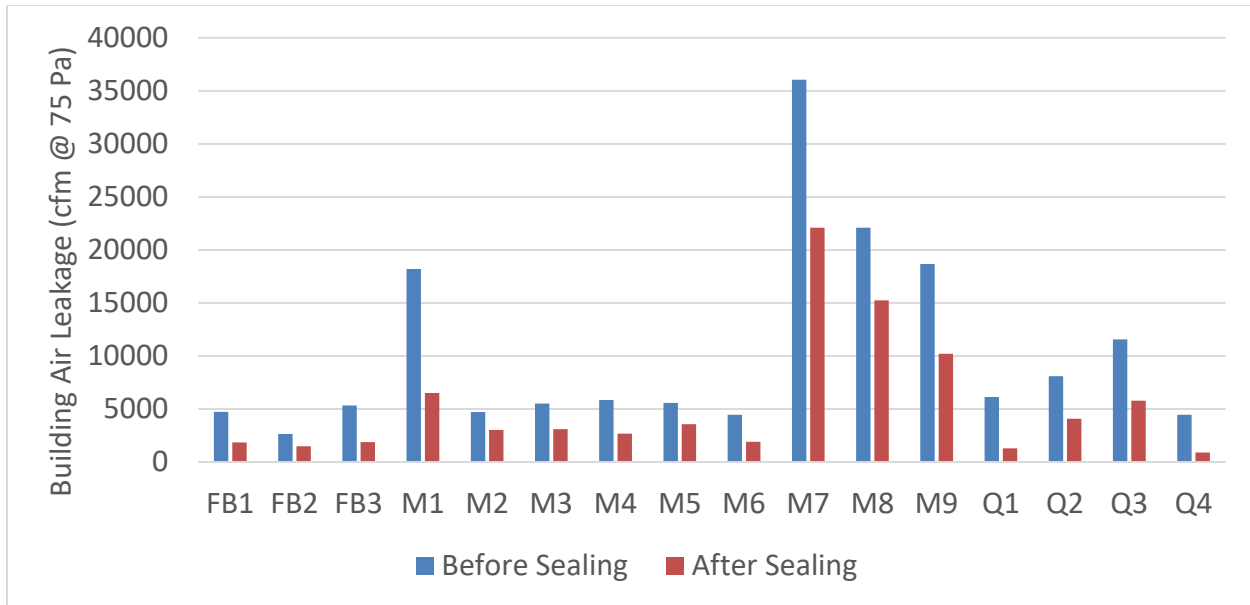
Figure 15. Pre and Post Air Leakage Test Results for All Demonstrations

This project demonstrated that the aerosol envelope sealing technology is very effective at sealing building leakage. Ultimately, over 75,000 CFM at 75 Pa was sealed over the sixteen demonstrations cutting the air leakage of the buildings in half. Figure 15 presents the pre and post air leakage measured in each of the demonstrations and Figure 16 presents the overall percent air leakage reduction for each demonstration. The most successful demonstration sealed 80% of the building leakage and three of the demonstrations brought the buildings to within the USACE specification for envelope leakage. This was impressive considering both of these buildings were in poor condition and scheduled for demolition.

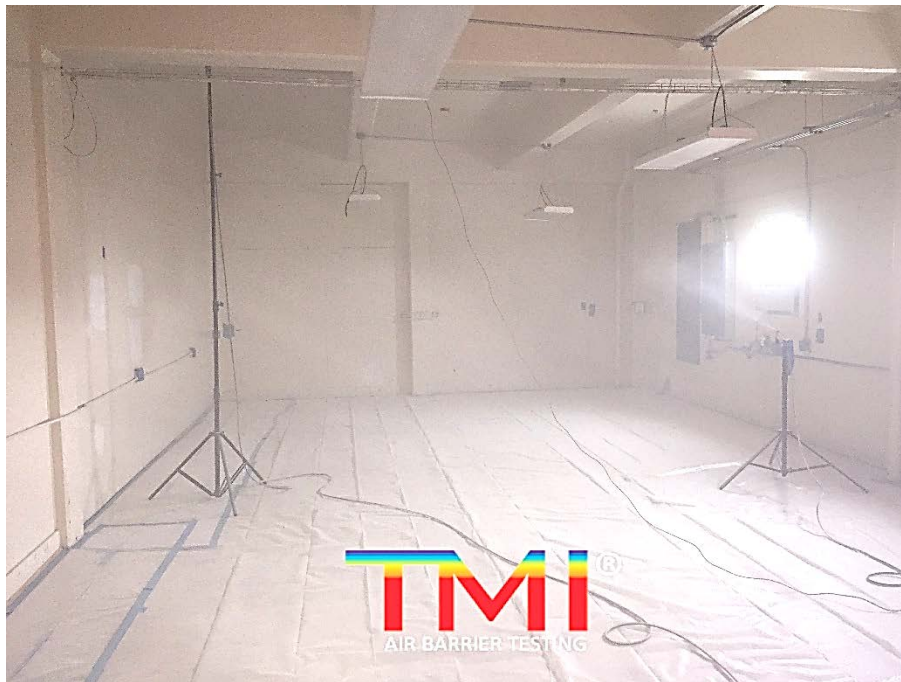
Another demonstration that took place at Quantico was the last demonstration for this project on a small office building. This building was vacant at the time of the aerosol sealing installation but was planned to be re-occupied at a later date requiring that the horizontal surfaces inside the building be protected (Figure 18). The prep work required about 16 person-hours or about one day for a two person crew.

Figure 18. Building 2177 at Quantico Prepped for Aerosol Envelope Sealing

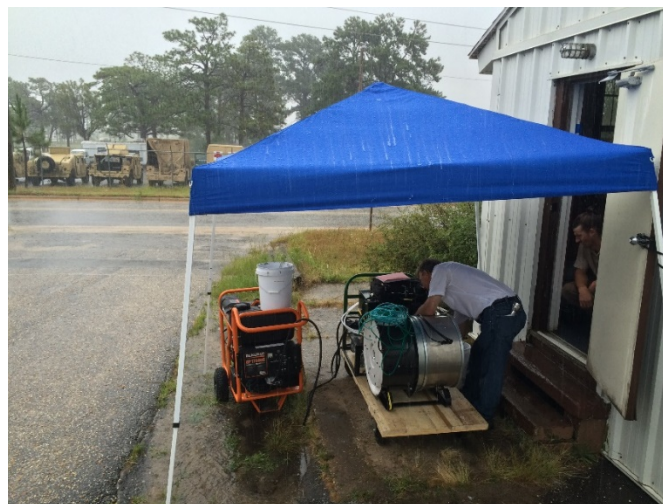
The three building sealed at Fort Bragg Army Base were completed between June 27-29, 2016. The weather during the demonstrations was considerably warm and humid, and in the case of the first demonstration, building A5436, there was periods of heavy rain (Figure 20). A total of eight nozzles were used during sealing of A5436 and Figure 21 shows the nozzle arrangement.

Figure 20. Setting Up Sealing Equipment in A5436 during Heavy Rain

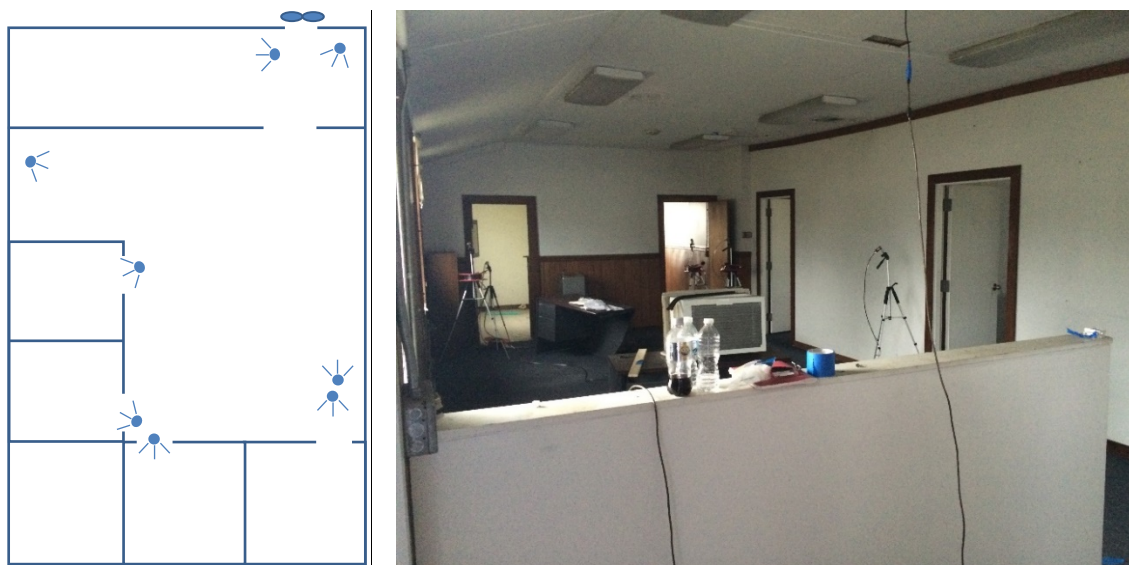
Figure 21. Nozzle Arrangement during Sealing in A5436 (left) and Photo of Nozzle Setup (right)

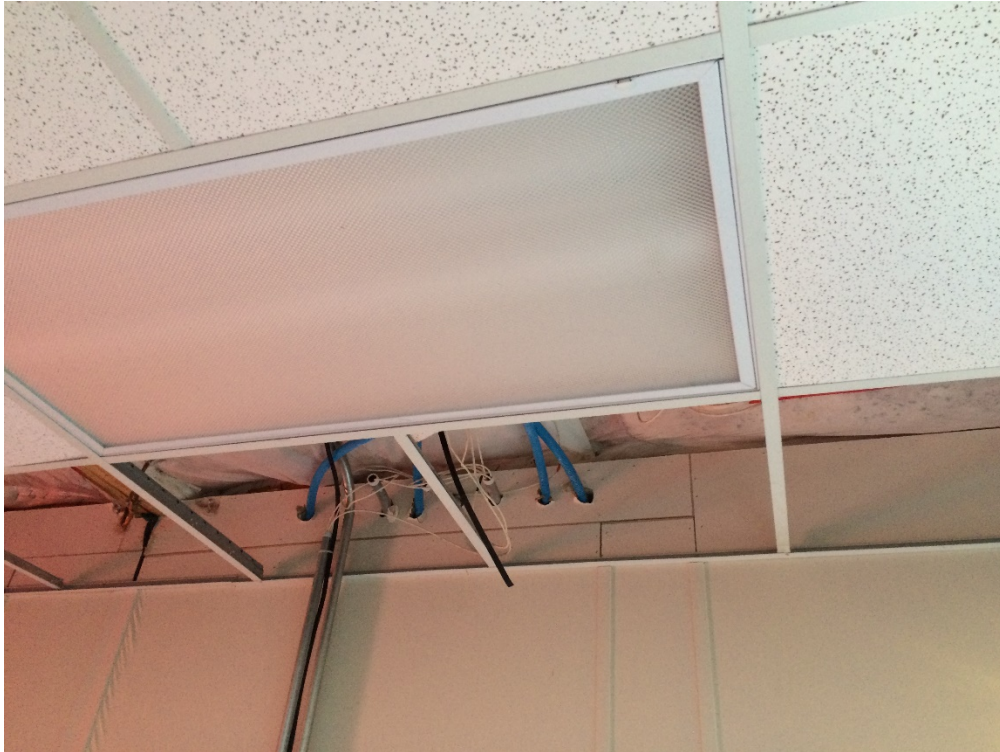
Building A6372 was sealed June 28, 2016. The building was in poor condition with the floor partially collapsed. There also appeared to be retrofits performed to the building to introduce network wiring through large conduits. The holes drilled for these conduits introduced significant leakage that was too large for the aerosol sealing to address (Figure 23). The overall impact of the aerosol sealing demonstration reduced overall building leakage by 44% from 2,643 CFM at 75 Pa to 1,479 CFM at 75 Pa. Figure 24 shows a seal formed at the baseboard of the building.

Figure 23. Conduits Installed in Building A6372 for Network Wiring

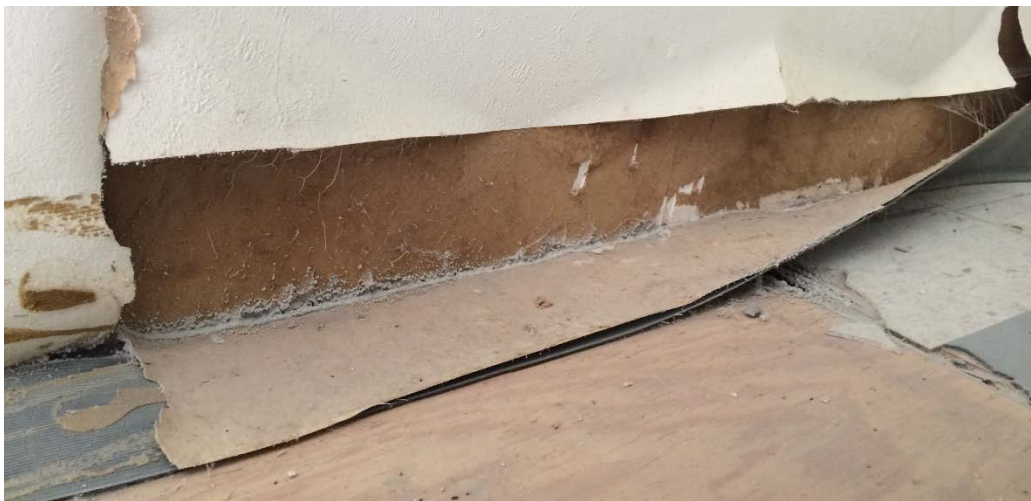
Figure 24. Photo of a Seal Formed at Baseboard of Building A6372 at Fort Bragg Army Base

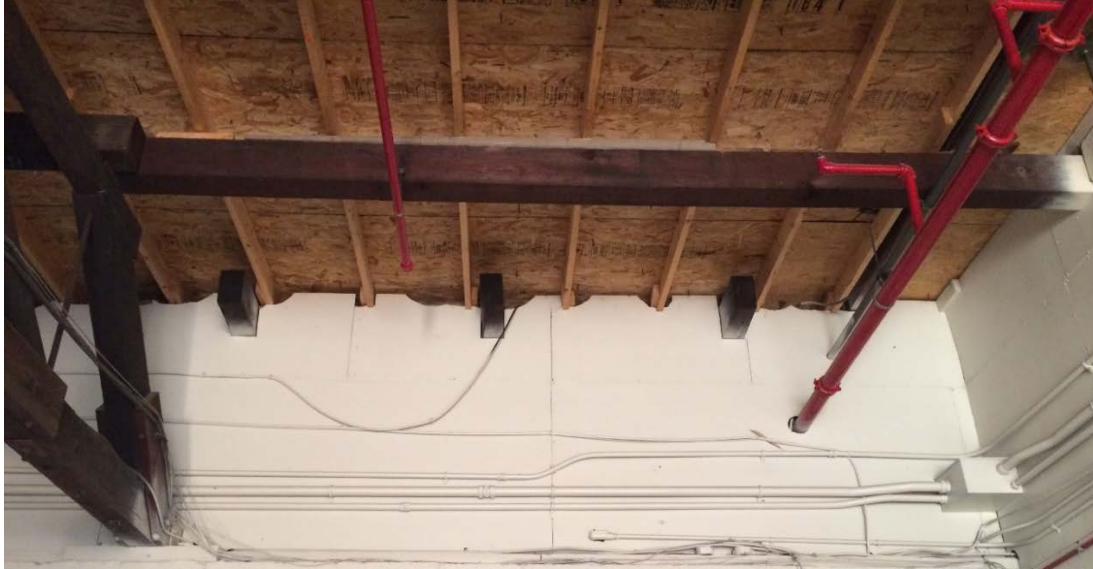
At first inspection it was assumed that some manual sealing would be required to deal with large holes in the wallboard (Figure 26), but after a closer look it appeared that the soffit construction behind the wallboard was built with suitable gaps for the aerosol sealing method to address. It was therefore decided to begin sealing without supplemental manual sealing. The building had several large roll-up doors that were temporarily sealed prior to the aerosol injection to prevent sealing those doors.

Figure 26. Photo Showing Large Holes in Wallboard at the Roof Rafters of Building M/608A at NSA Mechanicsburg

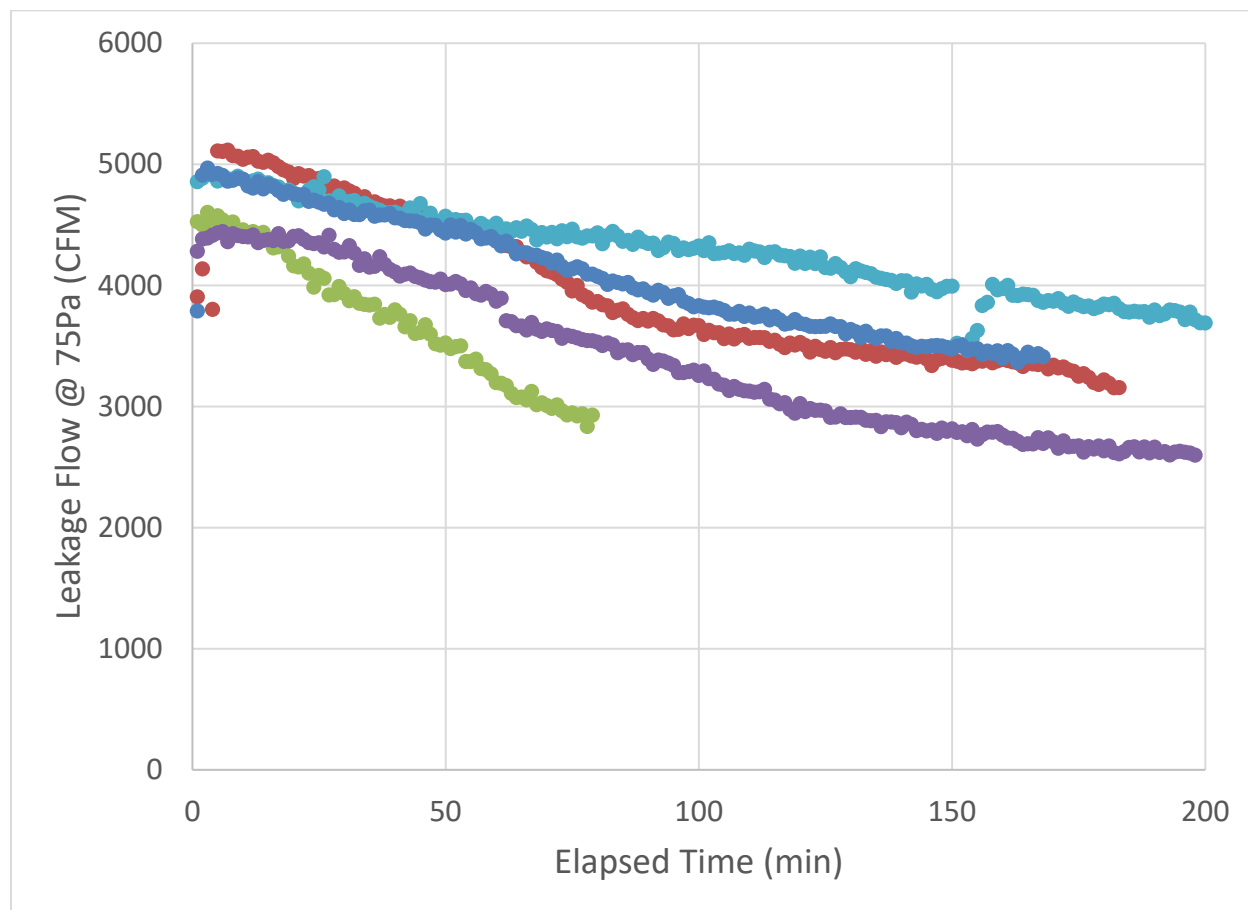
Five demonstrations occurred on individual apartments at a multifamily building at NSA Mechanicsburg. The apartment complex was scheduled for demolition and therefore did not require horizontal surfaces to be protected during sealing.

Figure 28. Sealing Profiles for all Five Apartments Sealed at NSA Mechanicsburg

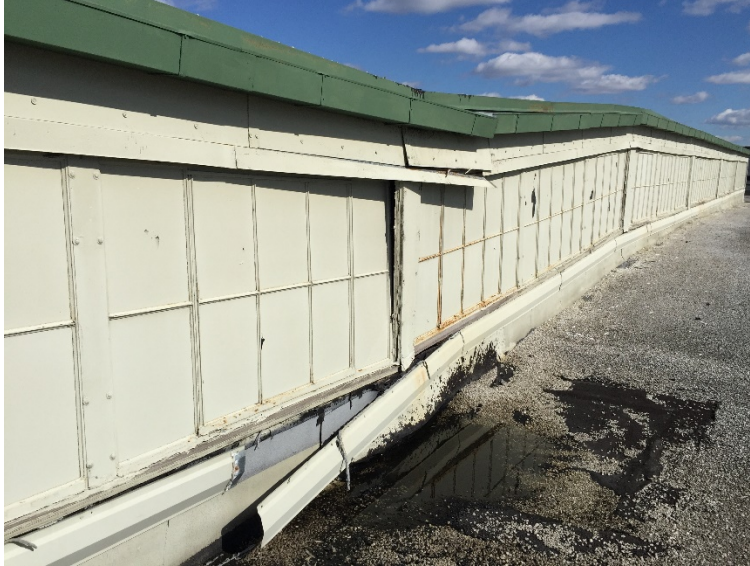
The last demonstration performed at NSA Mechanicsburg was on a relatively small bay of a larger building. Building 408 was a warehouse style construction with high ceilings and significant leakage issues at the roof (Figure 30). Much of this building was occupied including some adjoining spaces to the bay that was sealed.

Figure 30. Photo of Clerestory on Roof at Building 408 at NSA Mechanicsburg

The building started out with 18,760 CFM at 75 Pa and after sealing it dropped down to 10,205 CFM at 75 Pa representing a 45% reduction in envelope leakage.

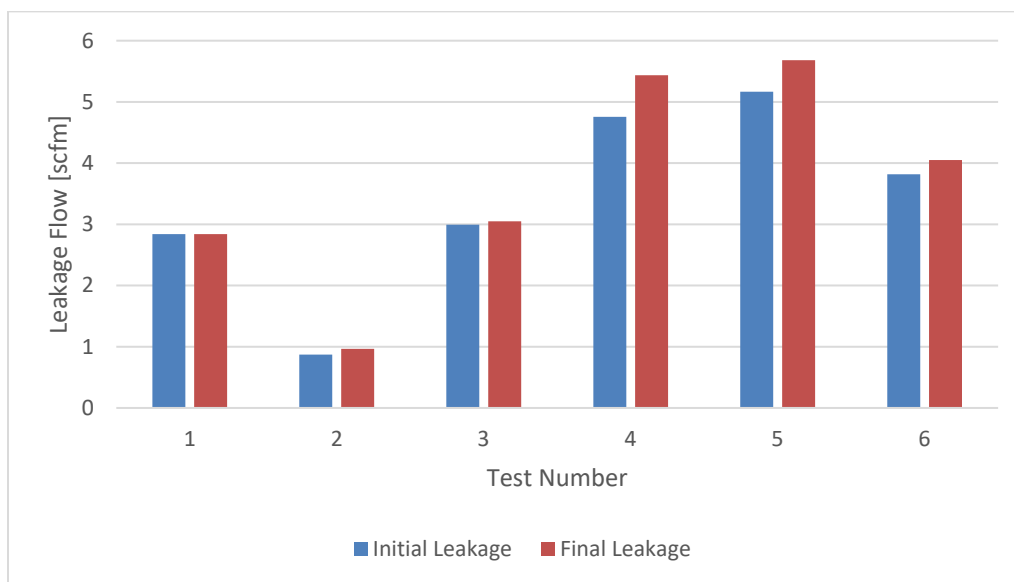
Figure 35. Initial and Final Leakage Flows for Each Test Sample During Failure Testing

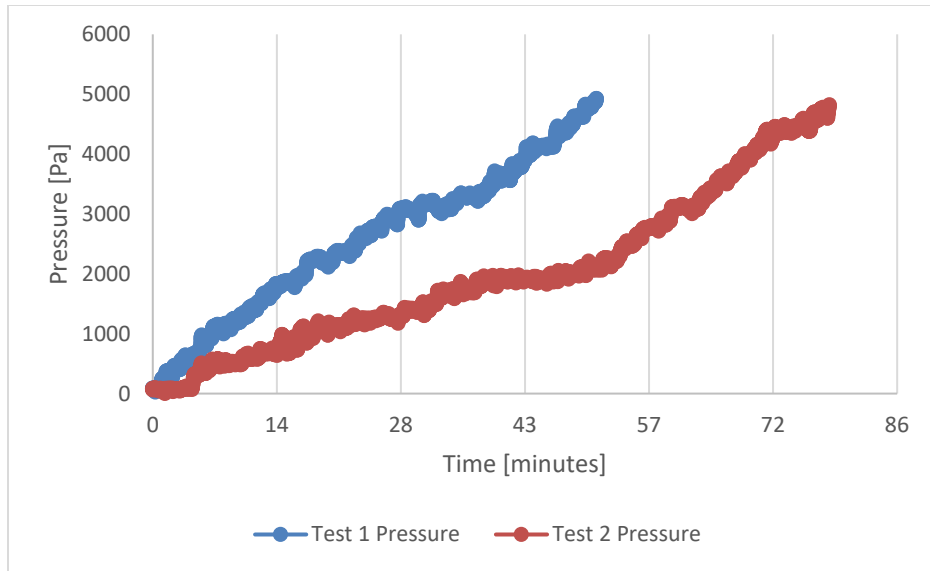
Figure 36. Pressure Increase Over Time for Ultimate Failure Test

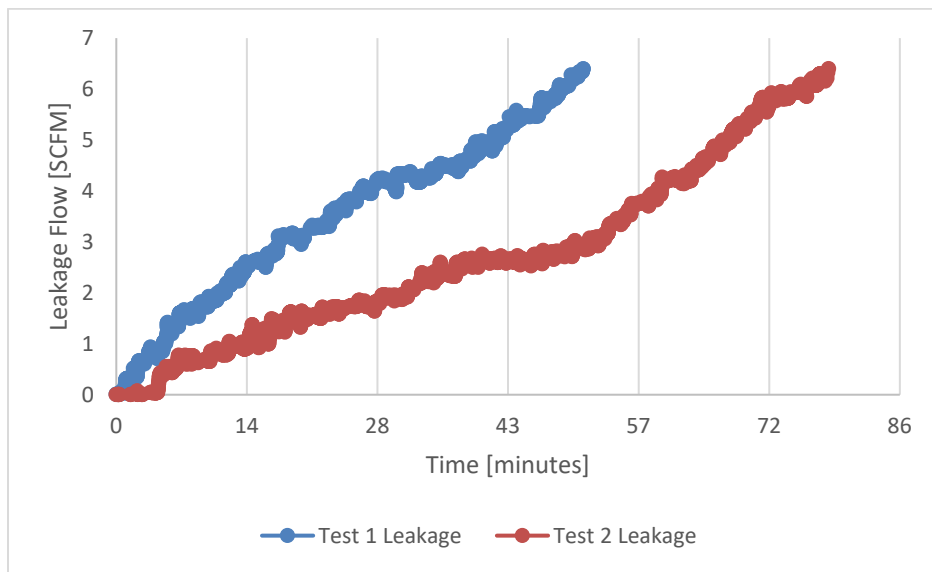
Figure 37: Leakage Flow Increase Over Time for Ultimate Failure Test

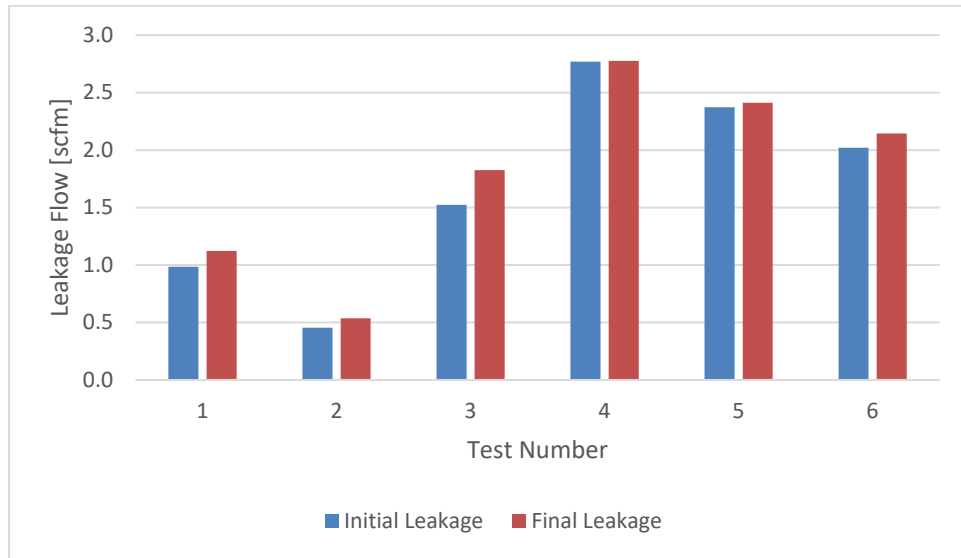
Figure 38. Change in Leakage After 1,000 Cycles of 800 Pa

(note: Test 3 experienced a significant over-pressurization resulting in higher percent change)

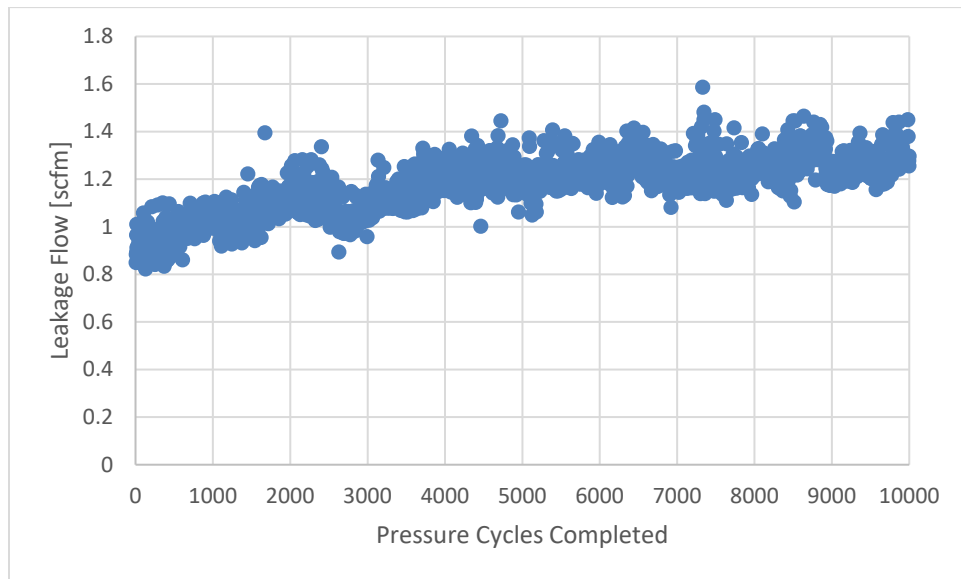
Figure 39. Leakage Rates Over 10,000 Cycles of 800 Pa

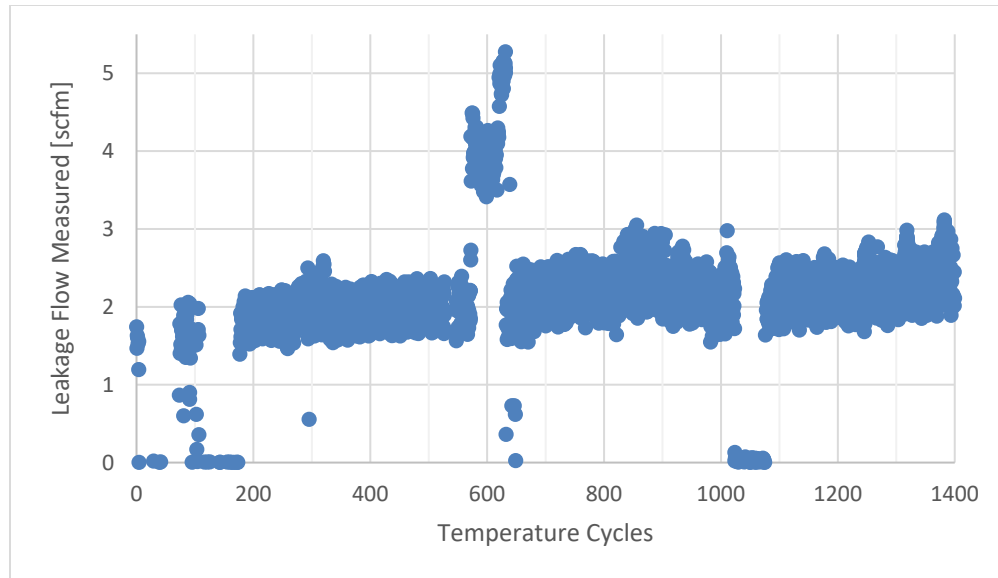
Figure 41. Leakage Flow Rate During Temperature Cycling While Maintaining 800 Pa

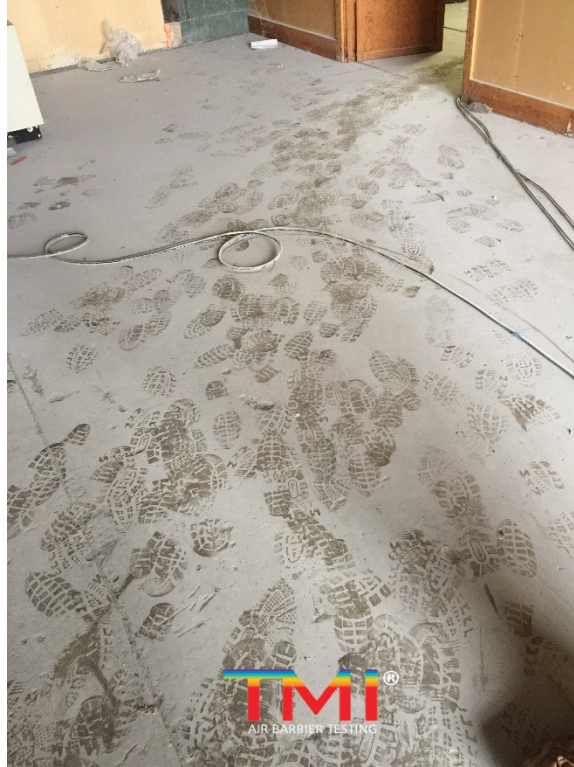
Figure 46. Photo of Floor Not Prepped at Building 608A at NSA Mechanicsburg
